THE KUTINA PYRAMIDS NATURAL LANDMARK – ITS DEGRADATION AND DISAPPEARANCE

ABSTRACT

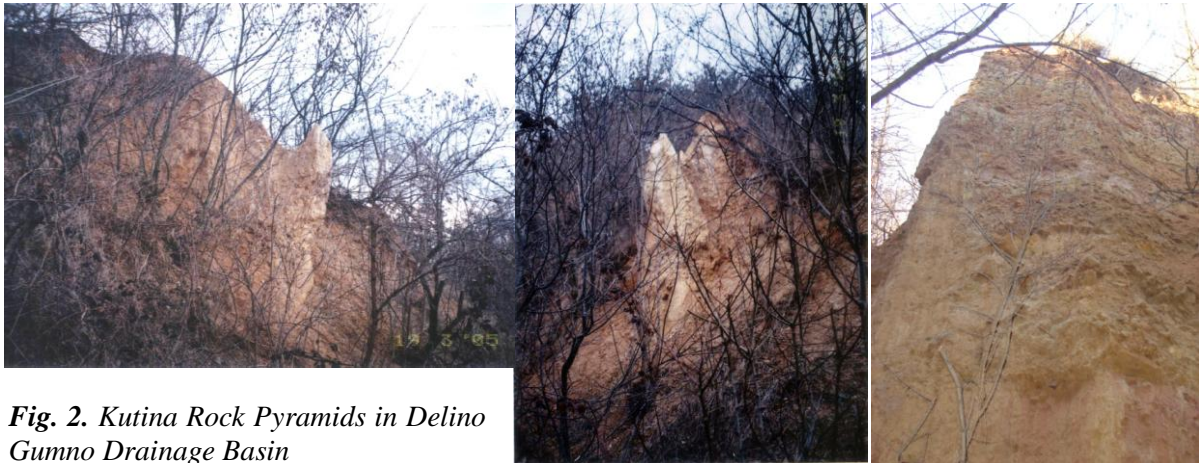
Fig. 2. Kutina Rock Pyramids in Delino Gumno Drainage Basin

Similar earth pillars are located northwest of Kutina village, in Delino Gumno Drainage Basin and their height reaches 5-10 m. According to data from various literature sources they are covered with stone caps. Today, these earth pillars are without stone caps and most of them are destroyed. The gully, where this small group of Kutina pyramids is located has intermittent flow, and in its lower part, it is barred from a built-up real estate, the waters being trapped by a catchment. Pyramids are currently among thick vegetation.

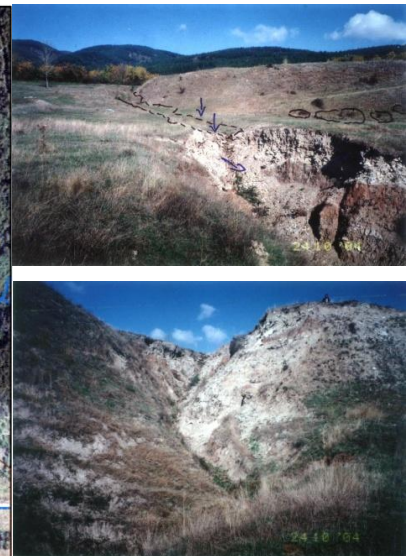
Fig.8. Deep linear erosion form
Across the technogenic slopes formed as a result of reclamation activities after the mine closure in 1973, a secondary segmentation of the slopes has begun which leads to the occurrence of a deep linear erosion forms in the active stage of development (Fig.8). In the period after 1973, when the mine stopped operating the processes of Kutina pyramids destruction continues and violate their dynamic balance.
